King Highway Landfill OU – 2013 1st
Semi-Annual Landfill Inspection Report

**KING HIGHWAY LANDFILL
POST-REMEDIATION INSPECTION FORM**

ALLIED PAPER, INC./PORTAGE CREEK/
KALAMAZOO RIVER SUPERFUND SITE

KING HIGHWAY LANDFILL OPERABLE UNIT

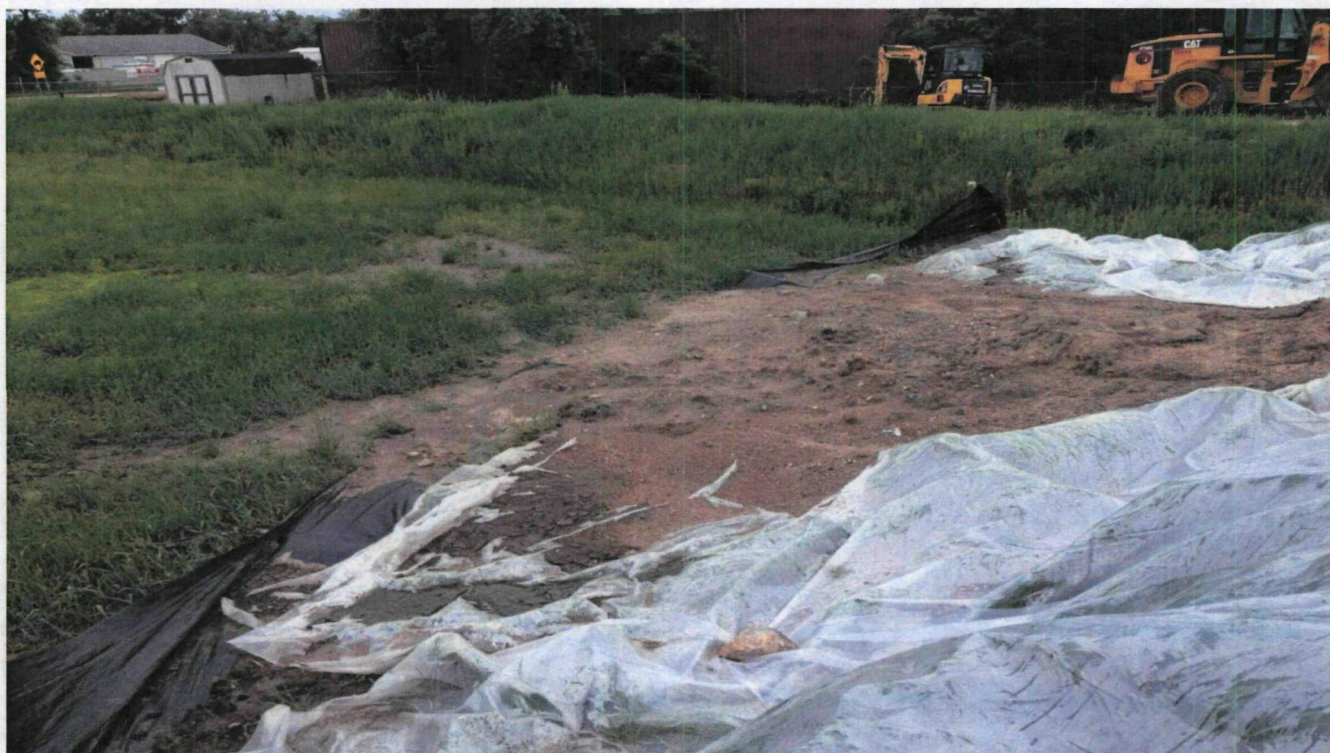
Inspection Items	Condition Satisfactory		Response	Comments/Proposed Action Items	Photo Nos.
	Yes	No			
Sedimentation Basin and Drainage Outlet					
Erosion	X		Regrade or place additional appropriate materials in the affected areas and promptly reseed to establish vegetative growth		
Siltation	X		Remove excessive sediment buildup that has caused filling of the basin bottom to elevations above the design elevation (e.g., design elevation near outlet structure is 764.5 feet)		
Debris Buildup		X	Remove debris washed out materials	Soil material produced from hydrovac operation during the recent installation of additional gas probes GW-18 through GW-21 was observed within the settling basin. This material has since been removed from the sedimentation basin and placed in a covered roll-off container, which will be removed from the site prior to the next landfill inspection. Work to be performed by Terra Contracting Services, LLC (Terra).	1

Photo No. 1: Photo shows the overburden soil material located within the sedimentation basin at the KHL.

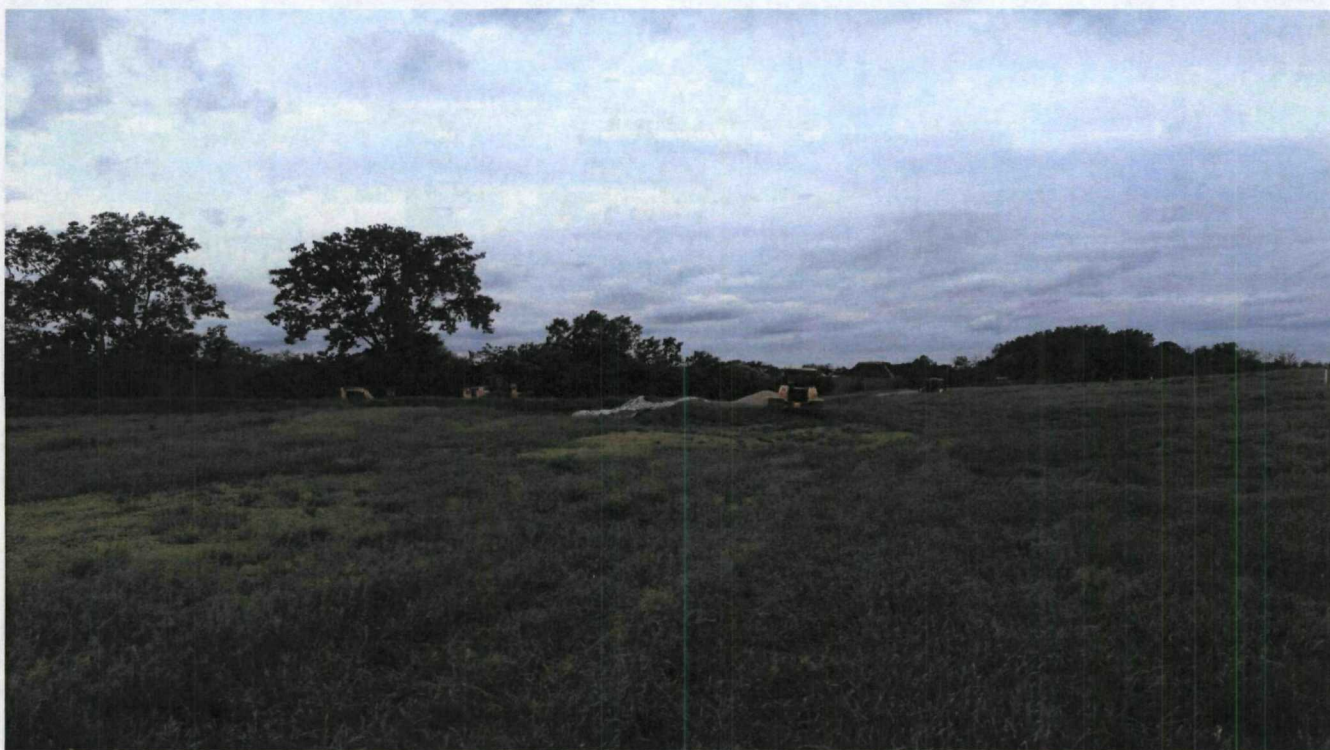
Condition of Discharge Structures & Inlets	X		Remove any debris or obstructions/blockages. Indicate corrective measures for damaged inlet or discharge structures		
Inappropriate Vegetation	X		Only grass will be allowed to establish on the cover. Roots of trees and shrubs will be cut out. Inspect the area every 2 weeks following removal to ensure that root systems have not returned		
Ditches and Diversion Berms					
Siltation	X		Remove excessive sediment buildup		
Debris Buildup	X		Remove debris washed out materials		
Disturbed Vegetation		X	Reseed areas of lost vegetation	Limited vegetative cover was identified in an area east of the sedimentation basin. This area will be to seeded and mulched to promote vegetative growth prior to the next landfill inspection, which will be performed by Terra. In addition, the area will be monitored for vegetative growth during the next landfill inspection.	2, 3, 4

Photo No. 2: Photo shows area of limited vegetation east of the sedimentation basin.

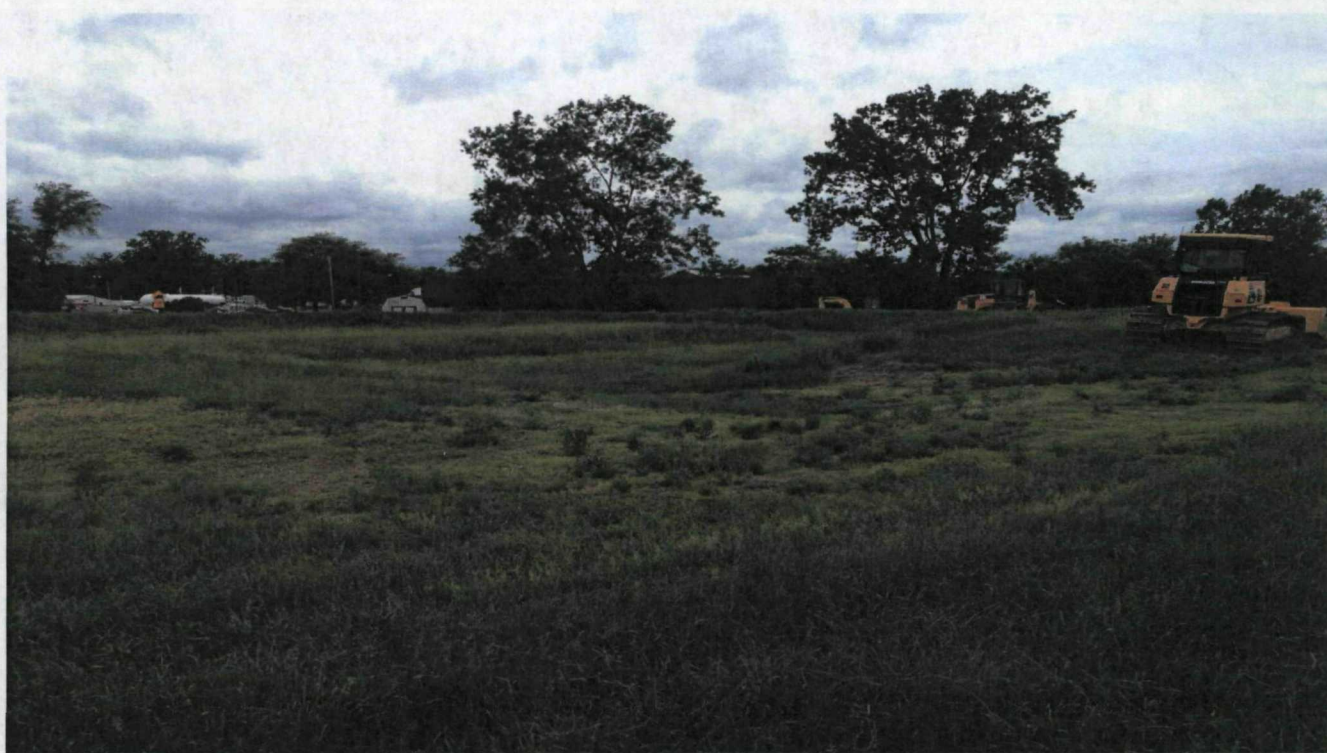
Photo No. 3: Photo shows area of limited vegetation east of the sedimentation basin.

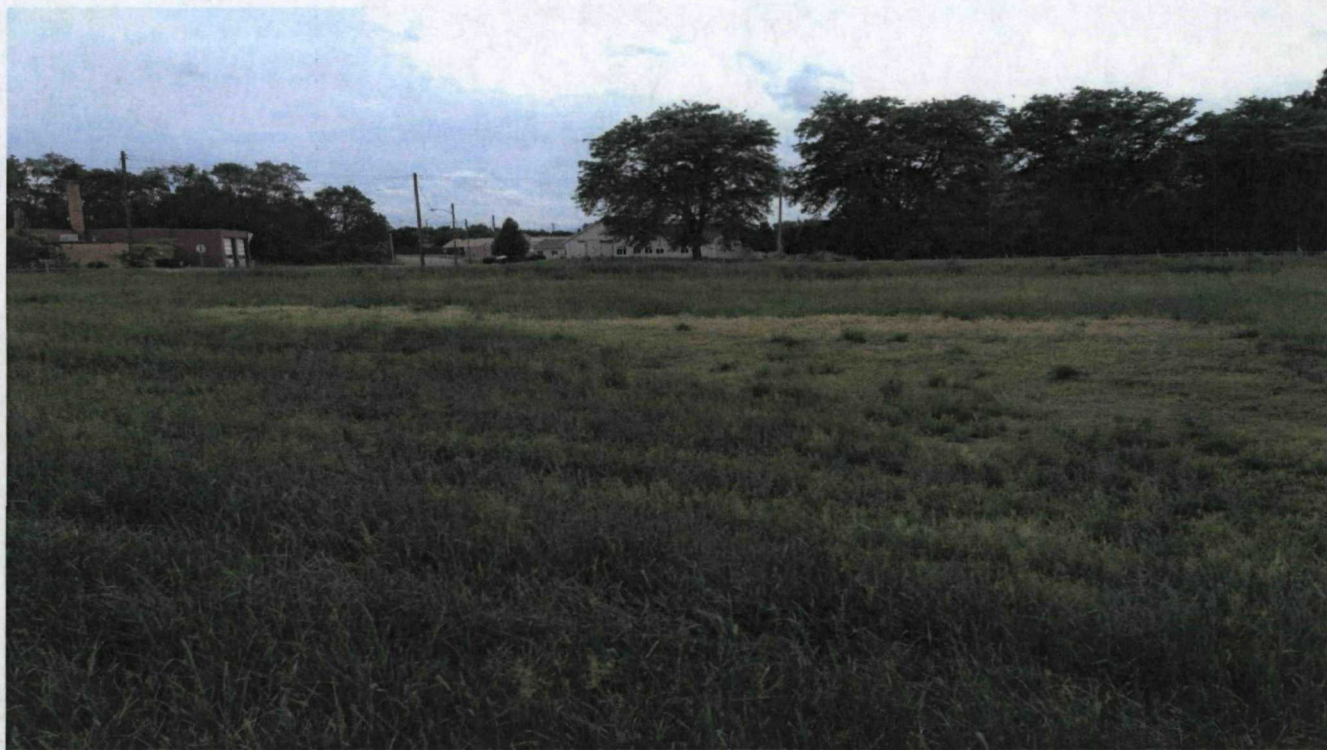
Photo No. 4: Photo shows area of limited vegetation east of the sedimentation basin.

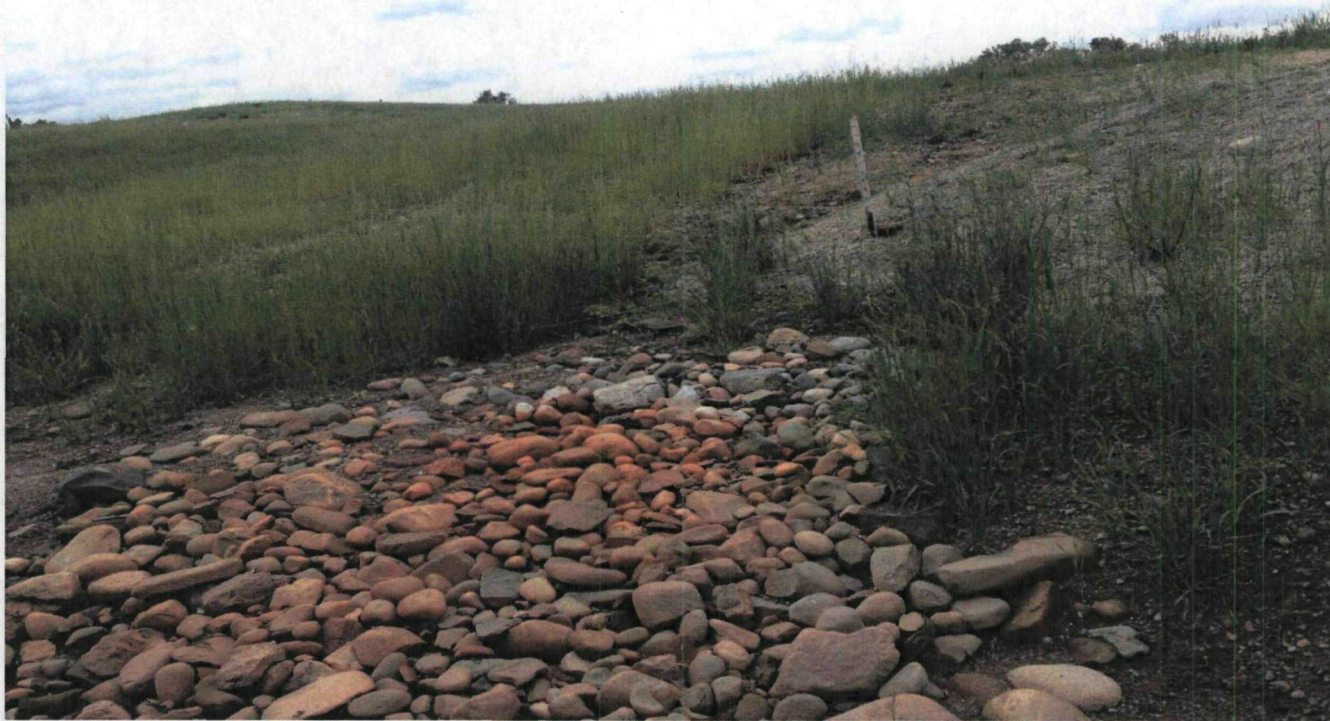
Sheet pile Wall					
Soil Erosion, Subsidence, or Cracking Behind Wall	X		Regrade or place additional appropriate materials in the affected areas and promptly reseed to establish vegetative growth		
Wall Joints	X		Note any gaps in the wall joints and any material migration from behind the wall		
Overall Wall Stability	X		Note whether the top of the wall has been displaced outward. Note any holes in the wall caused by corrosion		
Surface Water and Pore Water Collection System					
Clogging of Outlets	X		Remove any debris or obstructions/ blockages obstructing flow through the pipe		
Evidence of Settlement/ Exposed Materials		X	Regrade or place additional appropriate materials in the affected areas and promptly reseed to establish vegetative growth	Erosion rills were observed on the slope above the south pore water pipe outlet. This area will be regraded and seeded and erosion control blanket installed by Terra to prevent further surface erosion and rill formation and promote the establishment of vegetation to prevent future erosion along the slope. The slope will be monitored during the next landfill inspection for erosion and establishment of vegetation.	5, 6, 7

Photo No. 5: Photo shows erosion on the slope above the rip rap at the outlet of the south pore water discharge pipe.

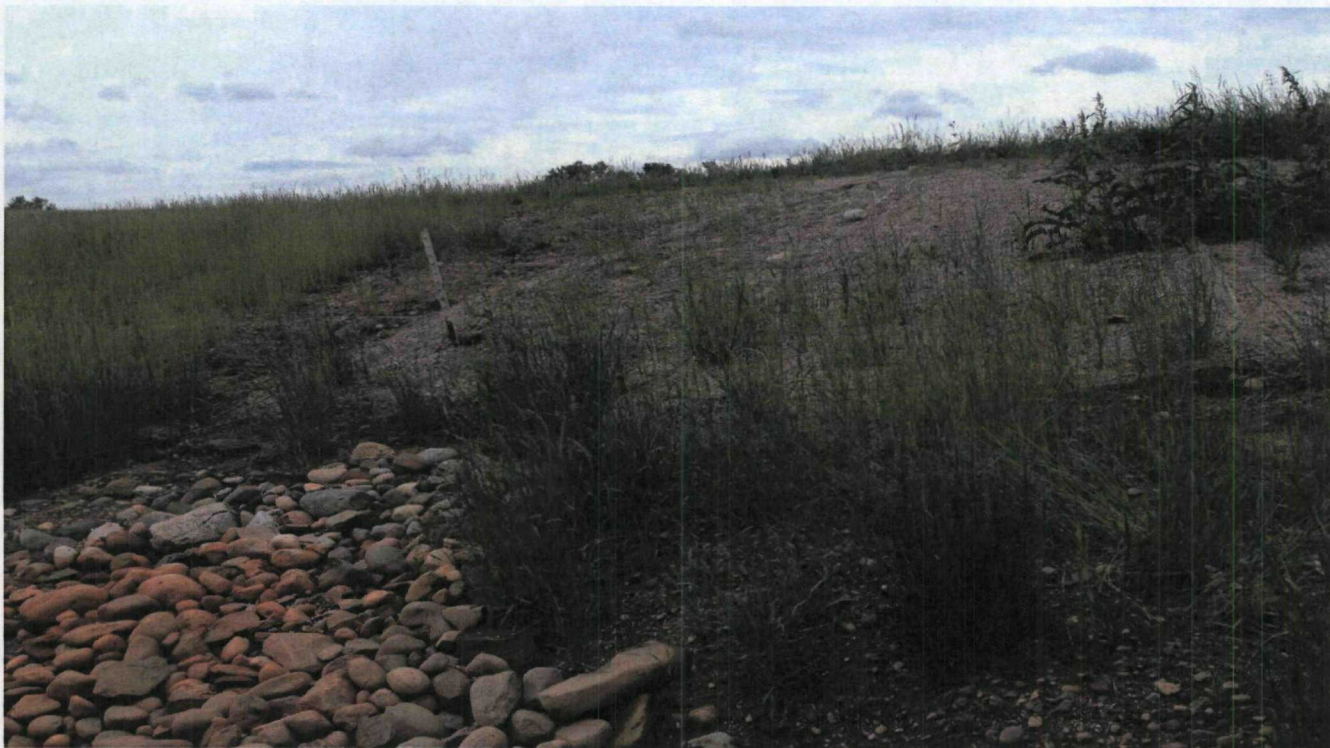
Photo No. 6: Photo shows erosion on the slope above the rip rap at the outlet of the south pore water discharge pipe.

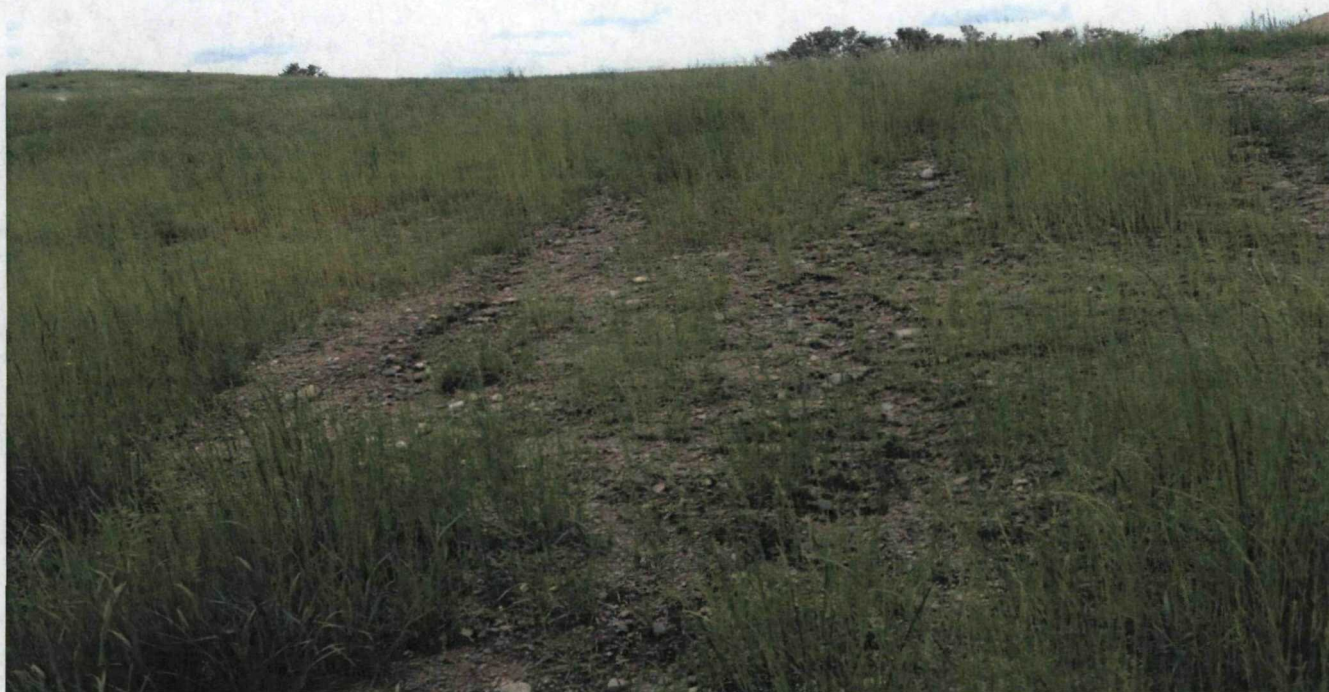
Photo No. 7: Photo shows erosion on the slope above the rip rap at the outlet of the south pore water discharge pipe.

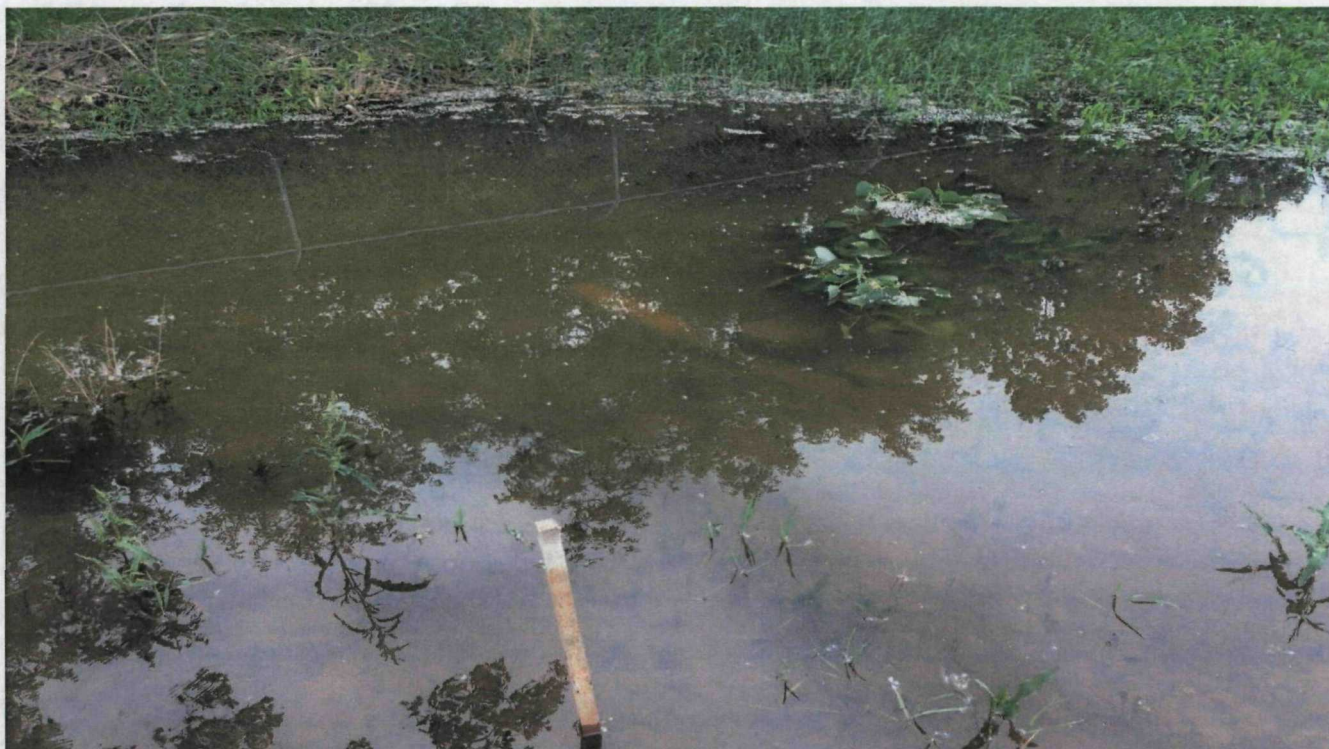
Condition of Inlet/Outlets	X		Replace or repair pipes that have been damaged such that flow is obstructed	The south pore water discharge pipe was observed to be under water at the toe of the rip rap. The south pore water pipe cannot be raised and still allow for positive drainage to occur. The pipe appears to be submerged only following significant rainfall events.	8

Photo No. 8: Photo shows the outlet of the south pore water discharge pipe under water.
